Musselshell River at Roundup: Detailed Floodplain Study

17th Annual AMFM Conference – Fairmont, Montana

Chad Bailey, PE CFM
Senior Water Resources Engineer - Bozeman

March 16, 2016

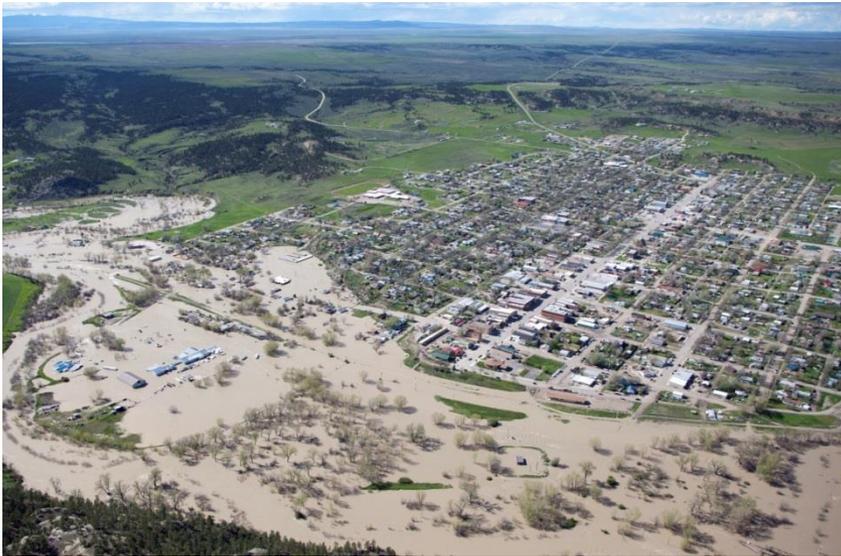
Kestrel Aerial Services, 2011 Flood Roundup

- May, 2011 Flood of Record ~15,000 cfs
 - Musselshell River over 4' above flood stage – 14.78' (USGS)
 - Closed Highway 87, 8' flood water at Busy Bee Café, 30 homes evacuated (Billings Gazette)
- March, 2014 Flood ~11,000 cfs
 - Musselshell River over 3' above flood stage – 13.24' (USGS)
 - Equivalent of 1" of rain in Roundup area (Weather Underground)
 - More than three dozen homes, businesses and ranches damaged
 - More than 400 people cut off from town (Weather Underground)

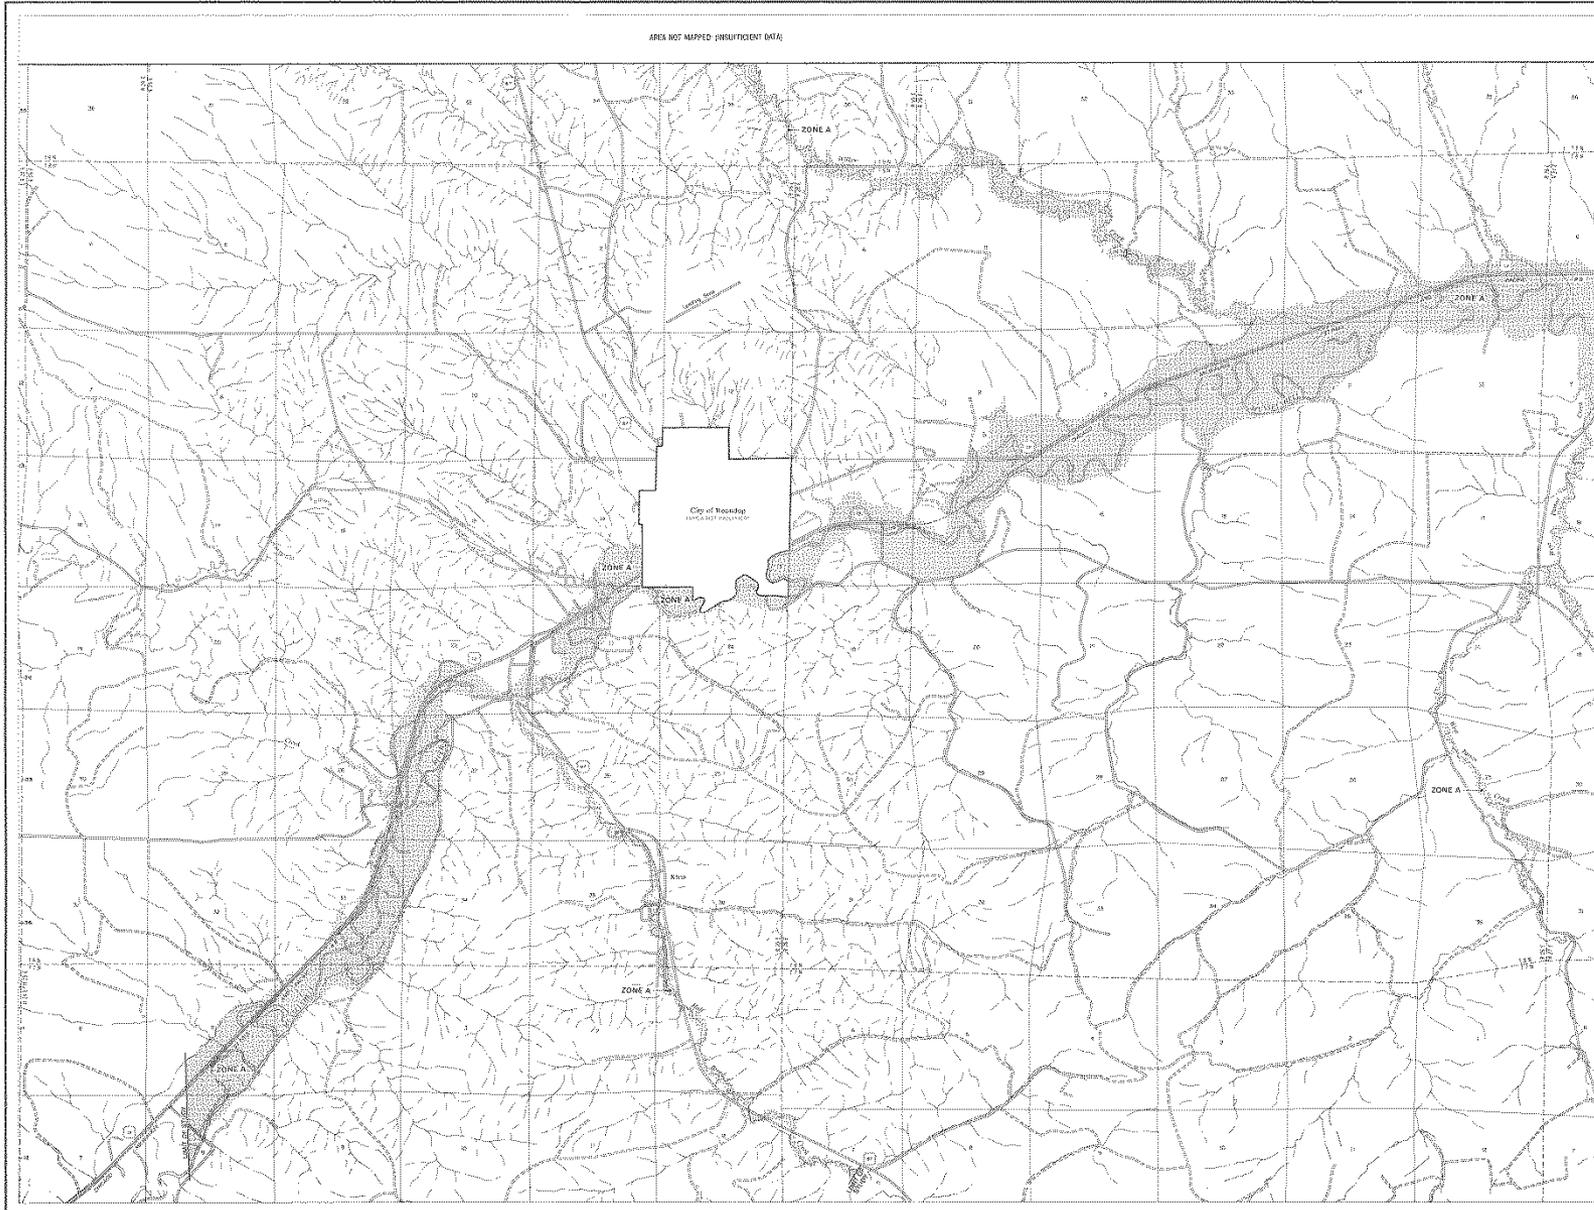
1979 Flood Hazard Boundary Map

Community:	Community No:	Panels:	Effective Date:
Musselshell County, MT	300174	14A	5/29/1979 (Zone A)
Roundup, MT	300050	1B	3/18/1986 (Zone A)

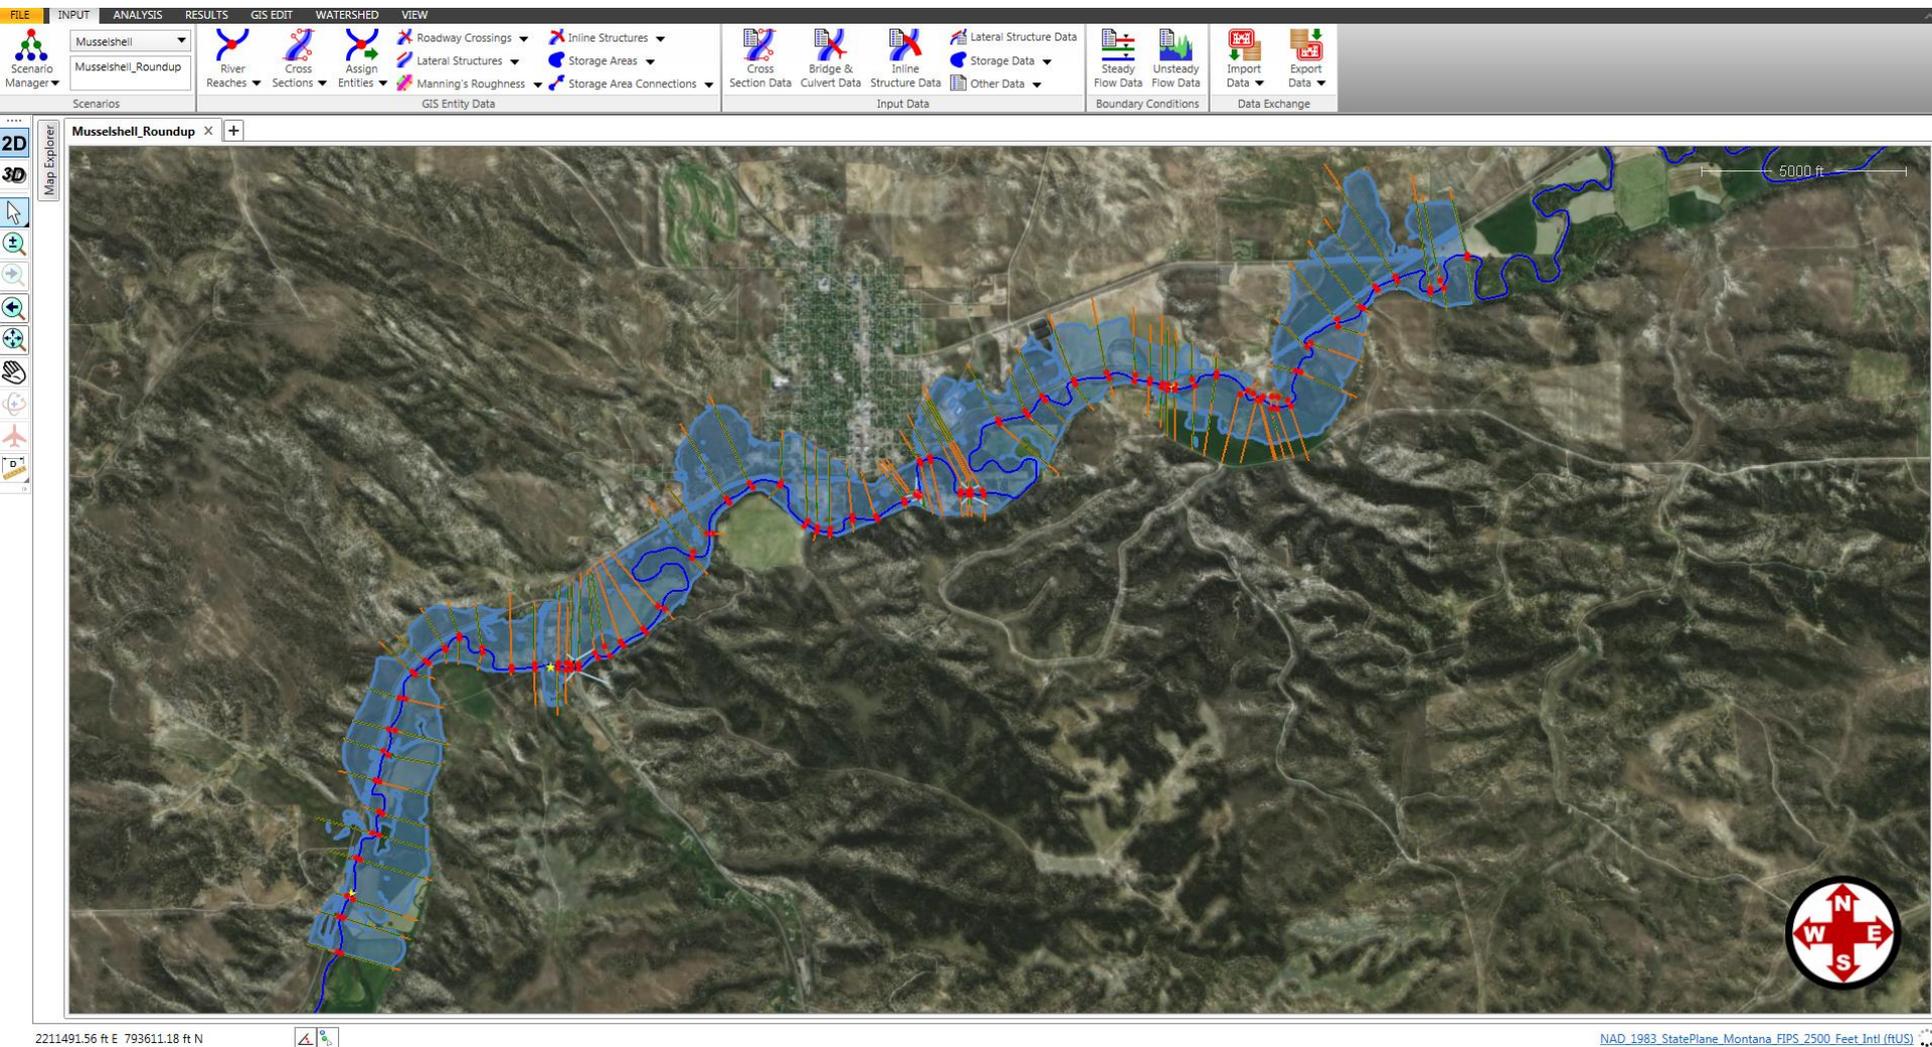
- GeoHECRAS (CivilGeo) – Example Screenshot

- GeoHECRAS (CivilGeo)
 - AutoCAD & ArcGIS integration with HEC-RAS model engine
 - HEC-RAS 5.0 official release February/March 2016
 - HEC-RAS 5.0 support in development with release expected mid 2016 (per conversation on 3/10/16)
 - Import integrated DEM for floodplain and channel surface (integrated Lidar & bathymetric survey – Phase 1)
 - Automated cross-section development & resampling
 - 600-700 feet spacing on average
 - Assign manning's n, bank stations, flow lengths, ineffective areas & levees using CAD or GIS data
 - Access existing FEMA & FIRM data
 - Cloud based DEM data
 - Cloud based orthoimagery

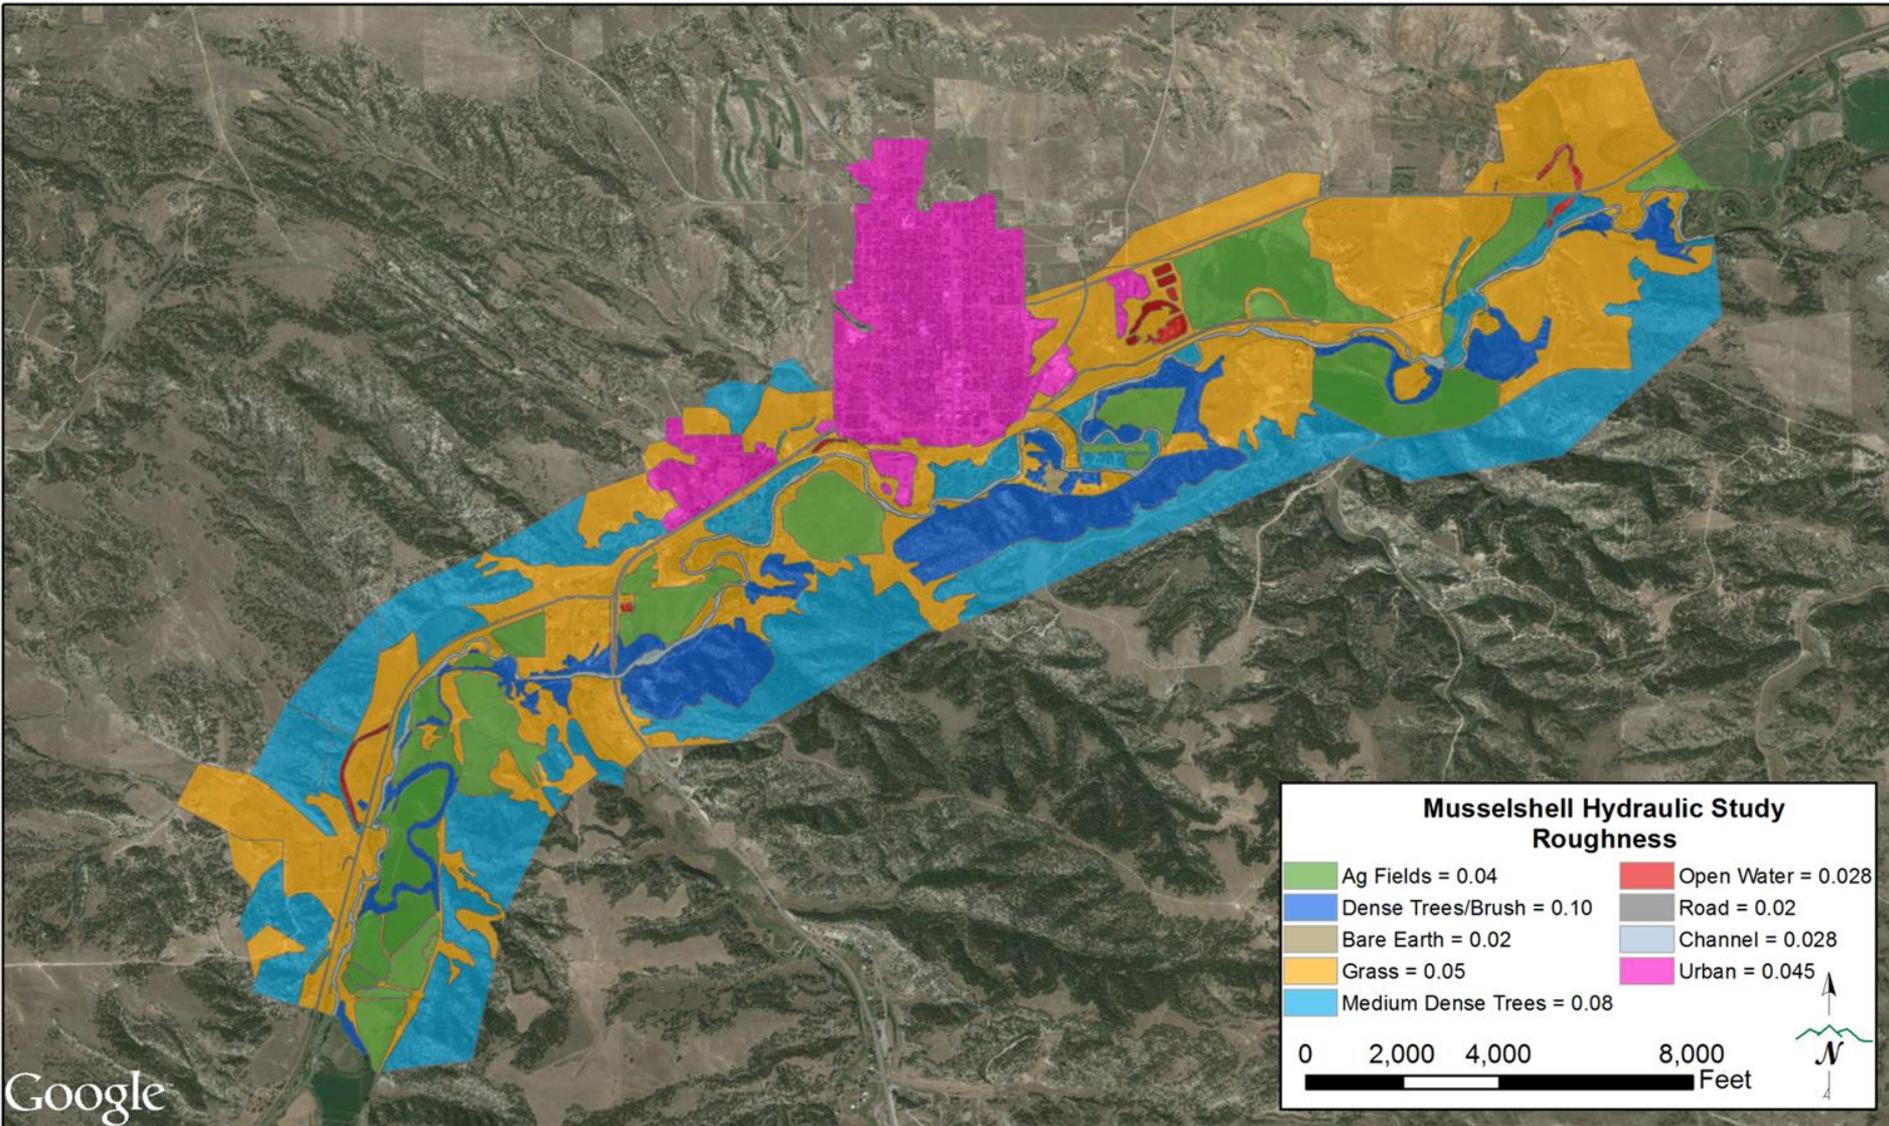
GIS Roughness Delineation

- ArcMap
 - Aerial imagery (2013 NAIP)
 - Visual polygon delineation – consistent land use
 - Assigned Manning's n attribute
 - Aerial imagery, field recon & photos, professional judgement
 - Chow (1959) & USGS (2006) methods to estimate initial roughness values
 - Adjusted during calibration procedure

Roughness Area/Land Use Type	Manning's n Value	Description
Main Channel	0.028	Coarse gravel ¹
Open Water	0.028	Same as main channel
Agricultural Field	0.04	Mature field crops, normal ²
Dense Tree/Brush	0.1	Heavy stand of timber, few down trees ²
Medium Dense Trees	0.08	Heavy stand of timber, few down trees (minimum) ²
Grass/Shrubs	0.05	Scattered shrubs, heavy weed ²
Urban	0.045	Finished concrete (0.015) + 15 to 50% obstructions (0.02) + small amount vegetation (0.01) = 0.045 ²
Compacted Dirt/Paved Road	0.02	Firm earth ¹
Bare Earth	0.02	Firm earth ¹

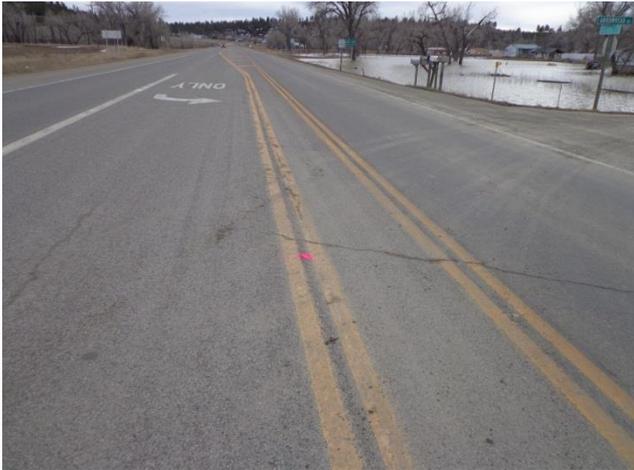
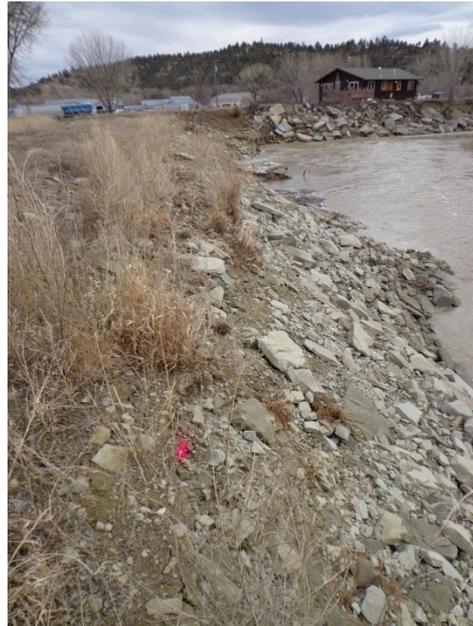
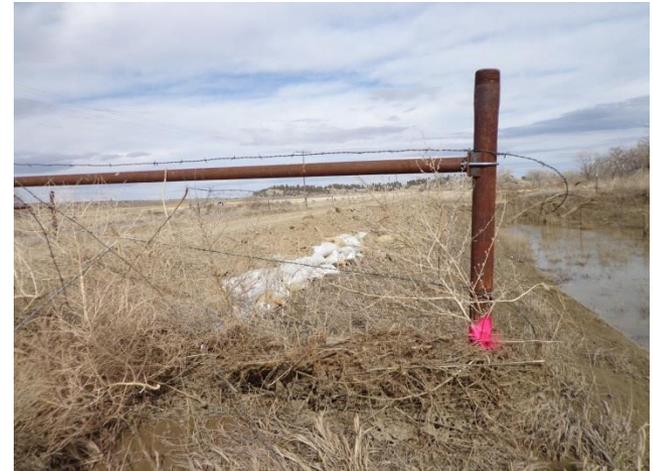
- High flow event on 3-10-2014 ~ 11,000 cfs
- High water marks and personal observations surveyed by Great West Engineering on 3-14 and 3-19 of 2014
 - 13 measured points with varying accuracy

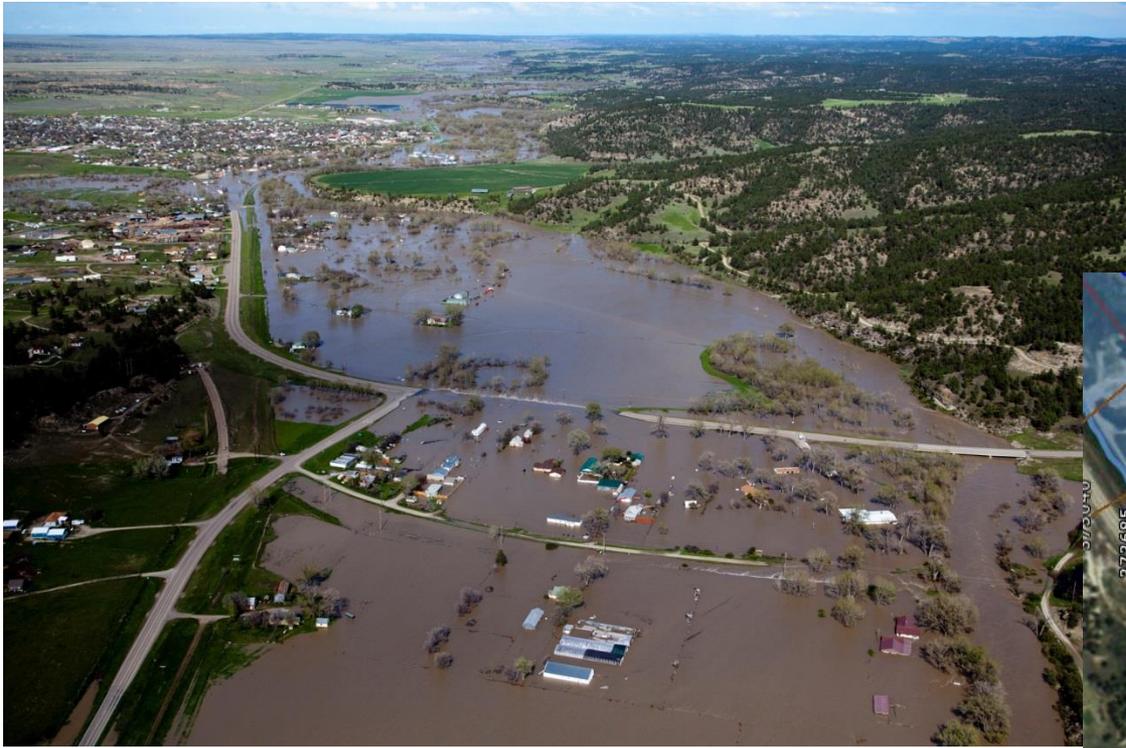
Highway 87 Comparison - Baseflood

Kestrel Aerial Services, 2011
Approx. 15,000 cfs

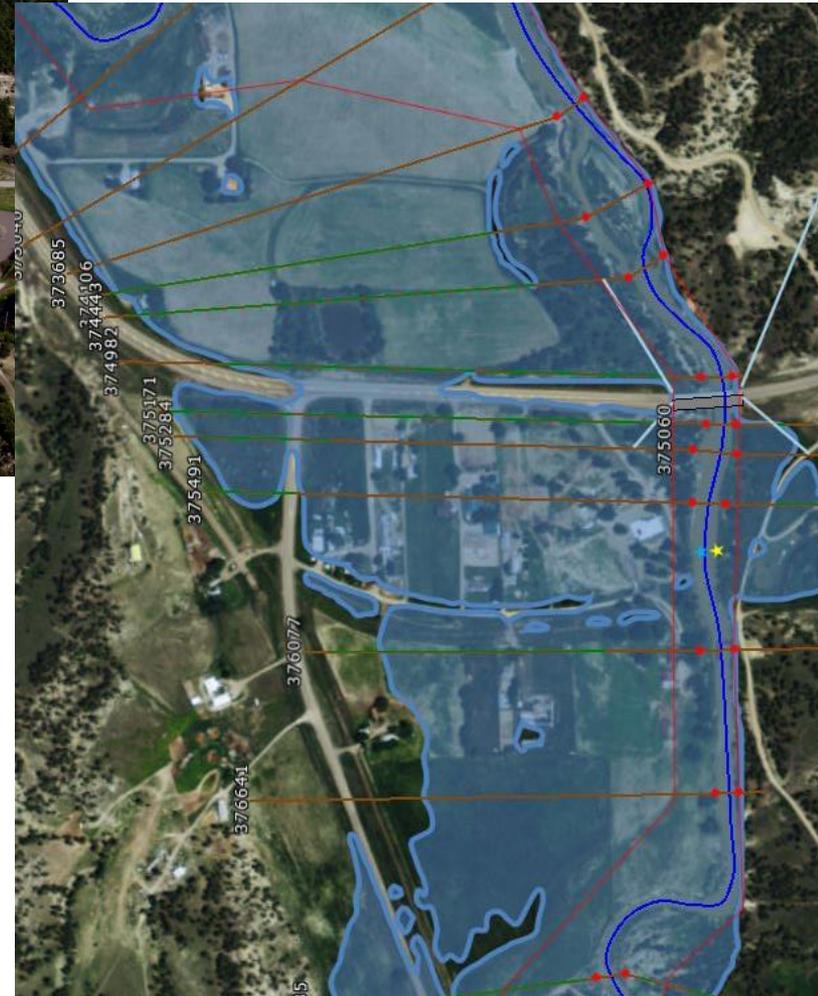
Hydraulic Model Result
Approx. 14,700 cfs

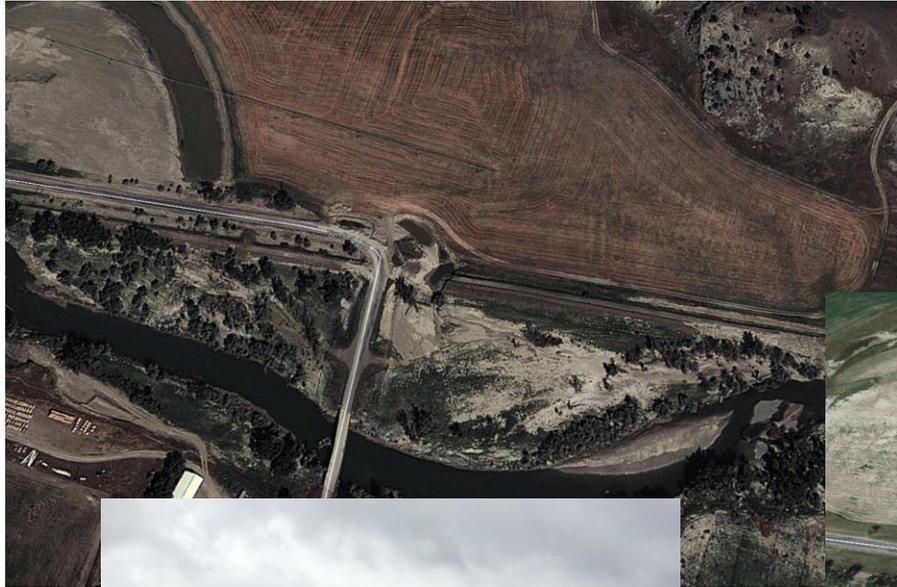
2011 Condition

- Number 4 Road Repairs
 - 2012 Lidar shows the spur road as damaged from 2011 flood
 - Lidar collected in 2012
 - Road repaired after 2013
 - DEM modified to approximate the current road condition and resultant inundation (not part of preliminary results)

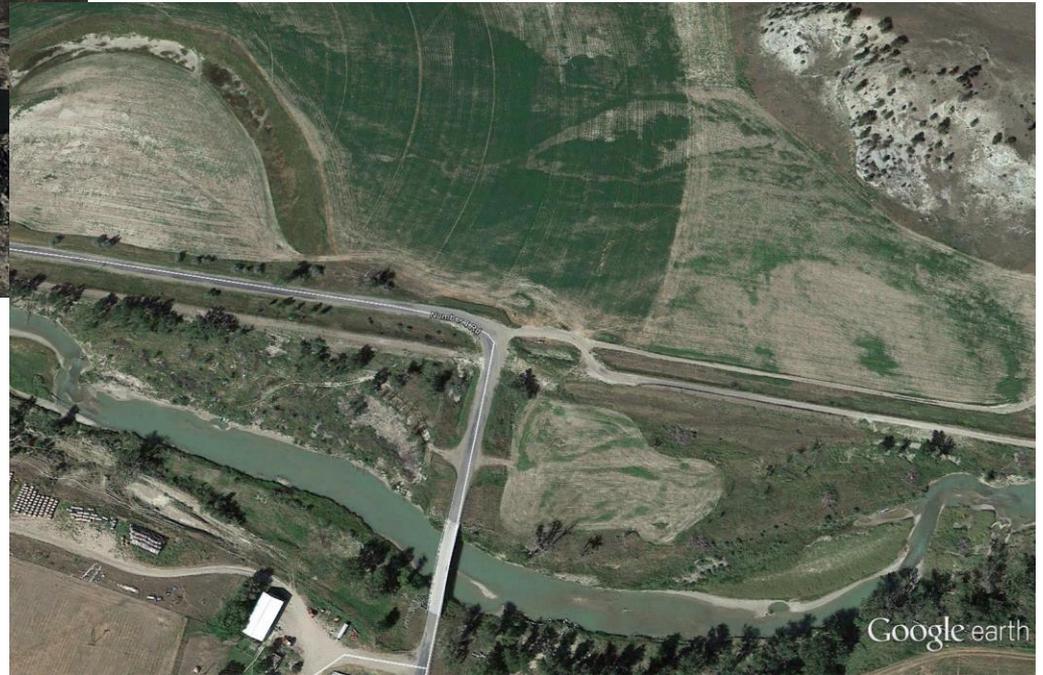
2013 Condition

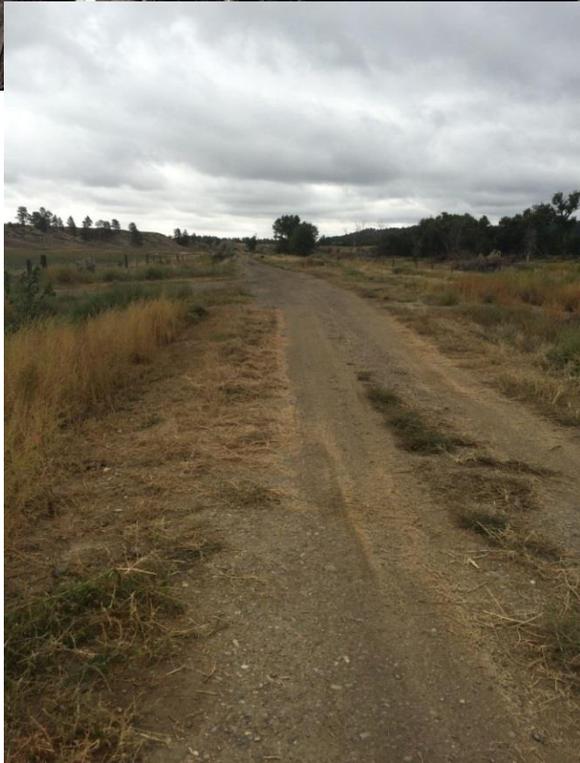
2015 Condition
(Looking East)

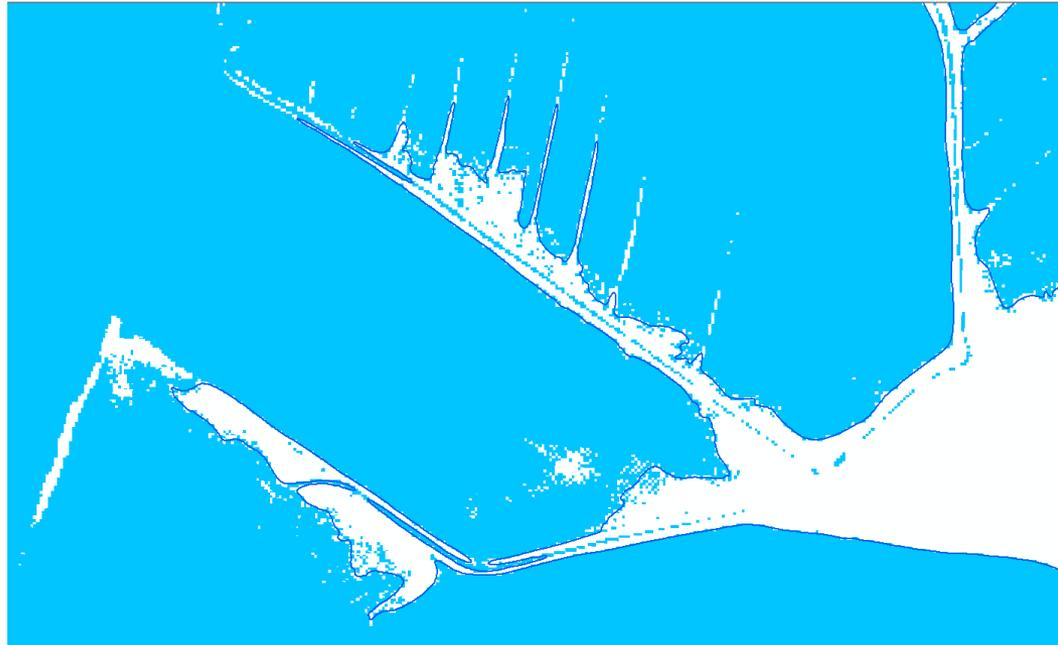
- Preliminary Inundation Simplification
 - Inundation boundaries required simplification when compared to detailed Lidar based DEM (1-foot/pixel resolution, 0.7m Lidar)
 - Simplify and smooth polygon tools removed pixilation and jagged boundary – did not fix all the anomalies of high resolution Lidar
